THE UNITED STATES
STRATEGIC BOMBING SURVEY

FIELD REPORT

Covering Air-Raid Protection
and Allied Subjects in

NAGASAKI, JAPAN

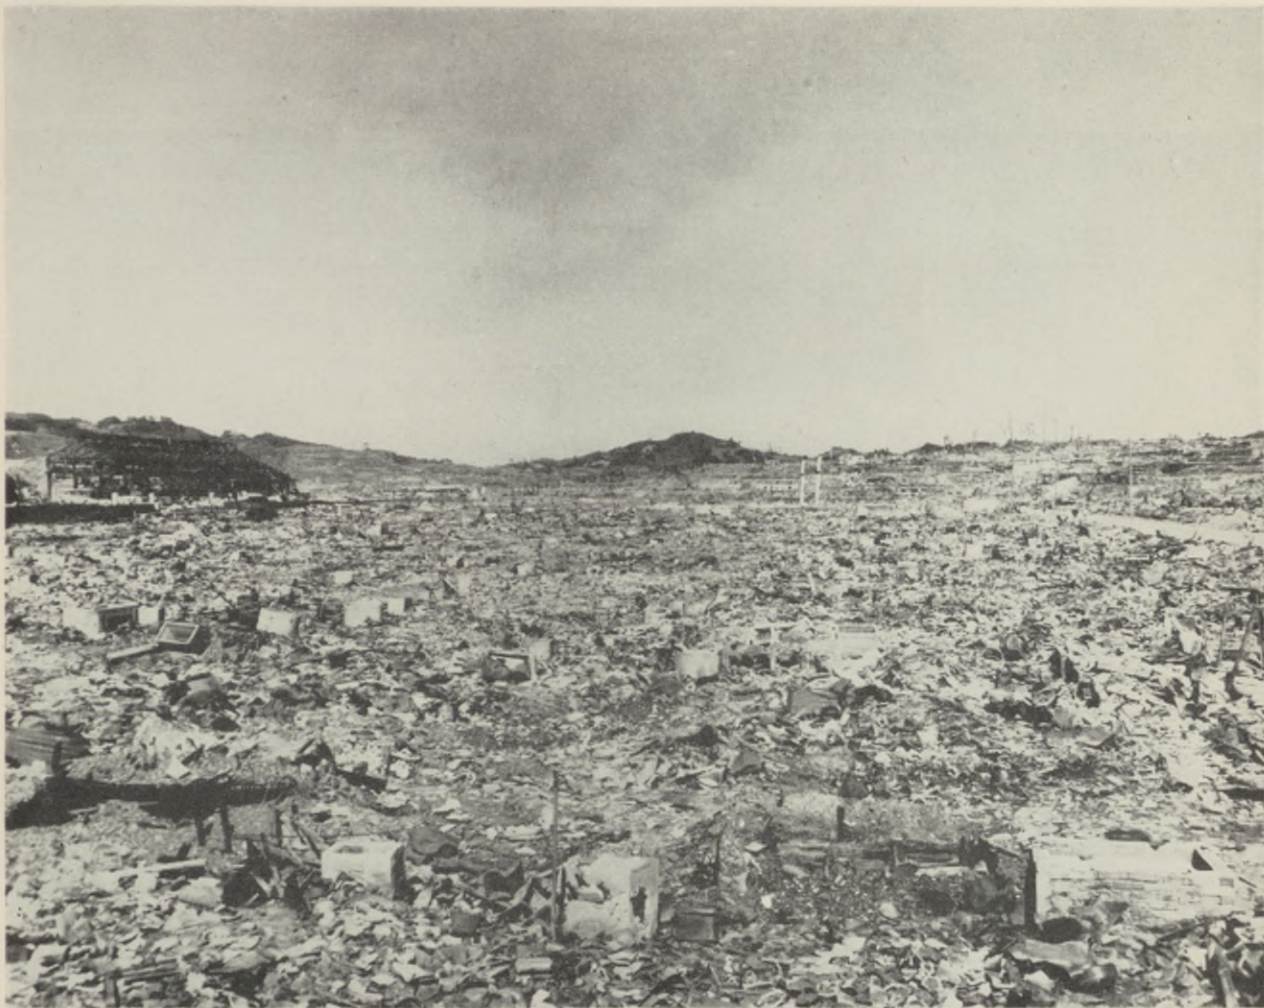
Photo 1. 2500 feet south of GZ. Looking north. Total damage by blast and fire.

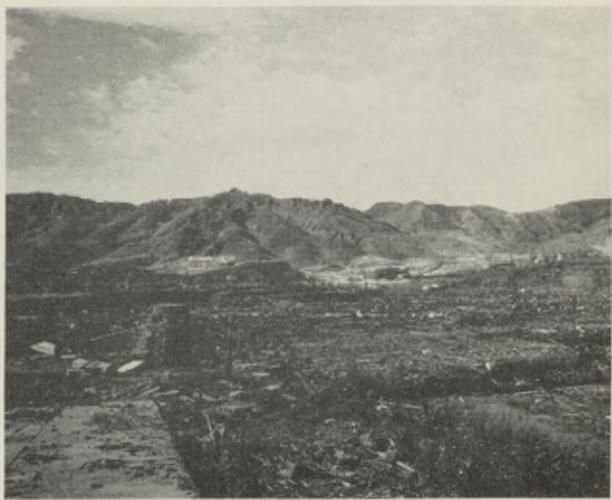
Photo 3. 1500 feet northeast of GZ. Blast and fire damage. Looking southwest.

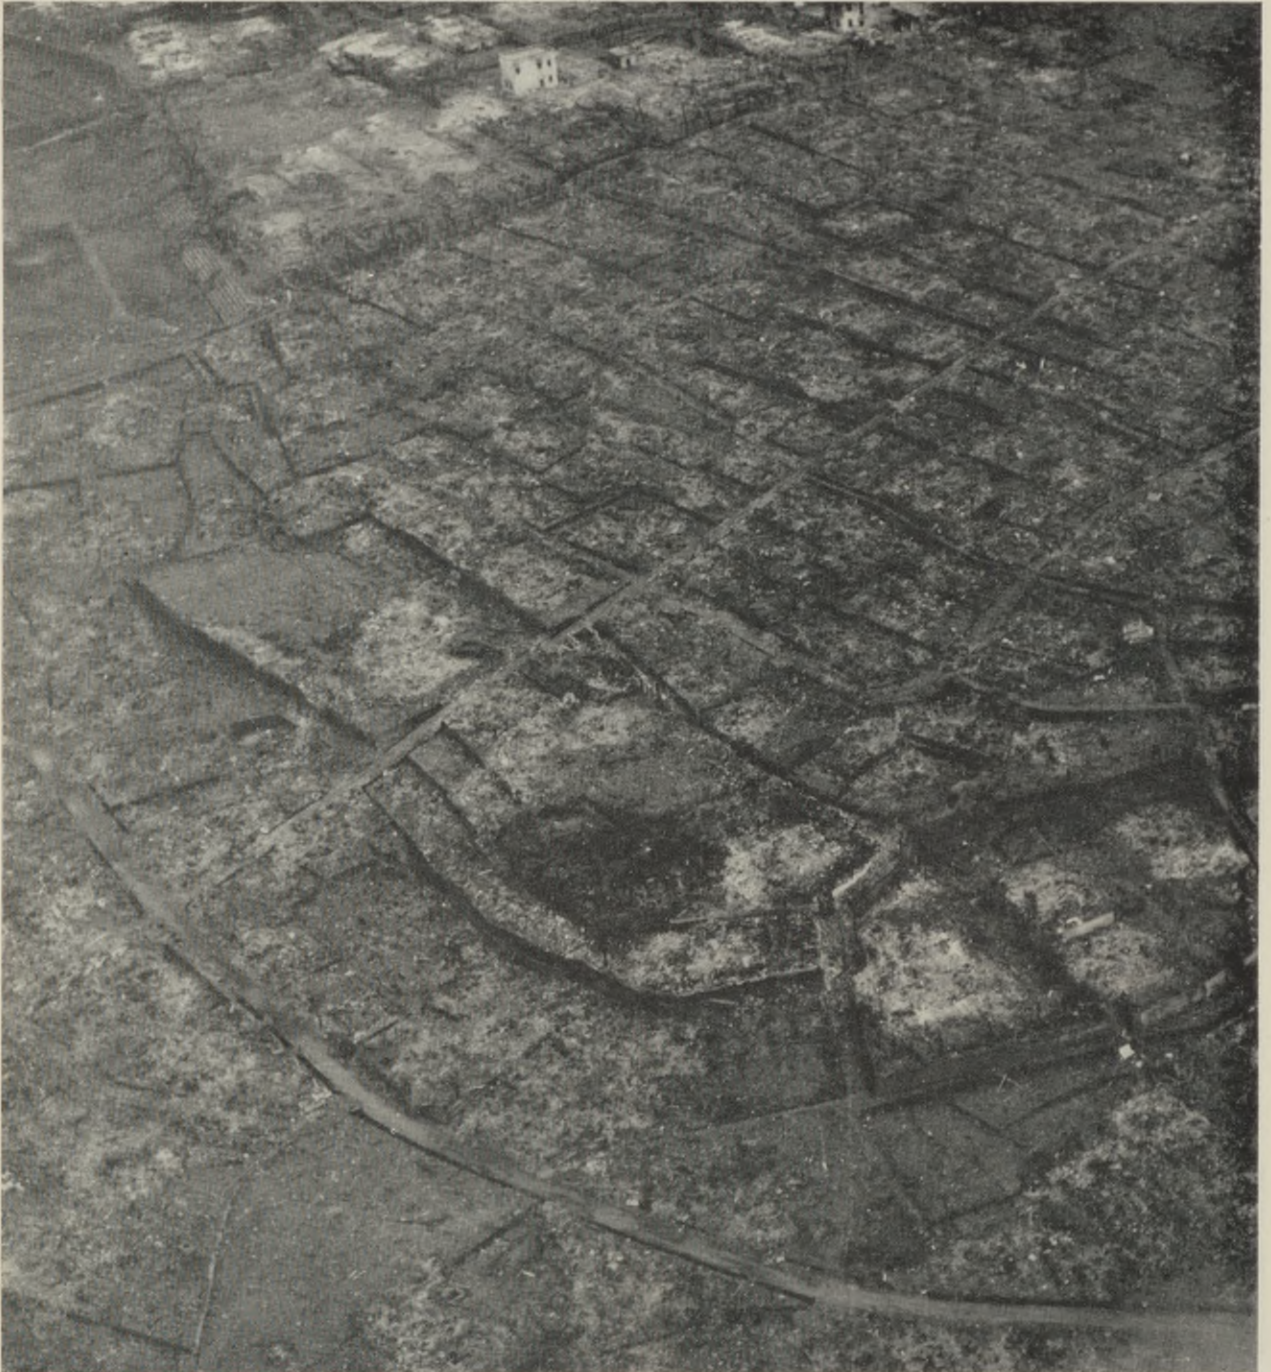
Photo 4. Looking southeast from a point directly over the Nagasaki Prison. This hillside was crowded with typical Japanese wood-frame houses. In the upper portion of the photo can be seen the northwest corner of the Nagasaki Medical College.

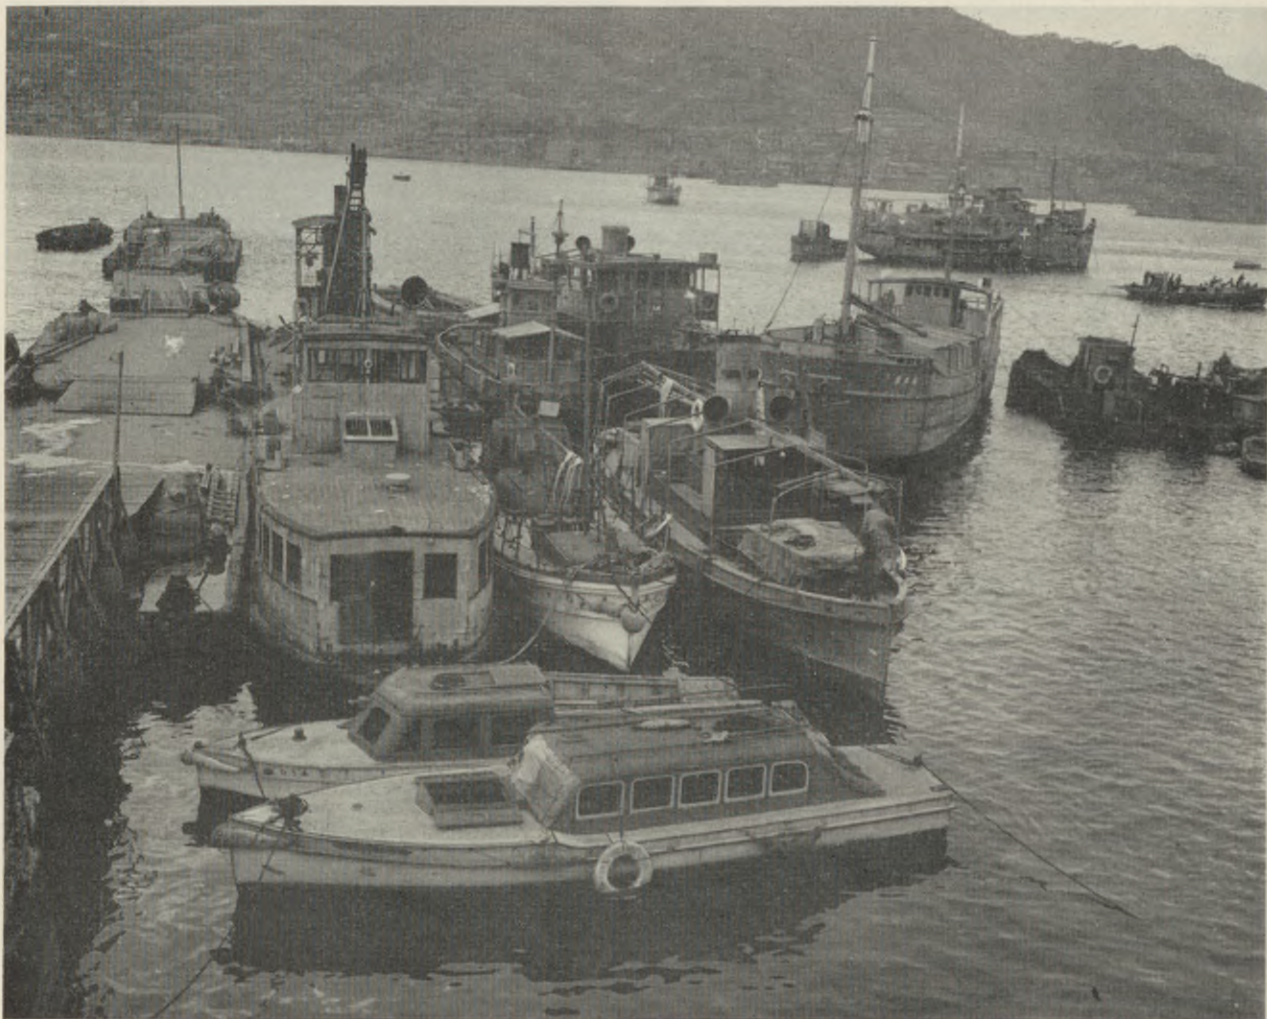
Photo 7. The two boats in center of picture with bows forward, the one on left having white hull, and one on right having smokestack, are the water police patrol boats. These boats were completely hemmed in by other small craft and it took 6 minutes for the boat on the right (outboard) to get under way.

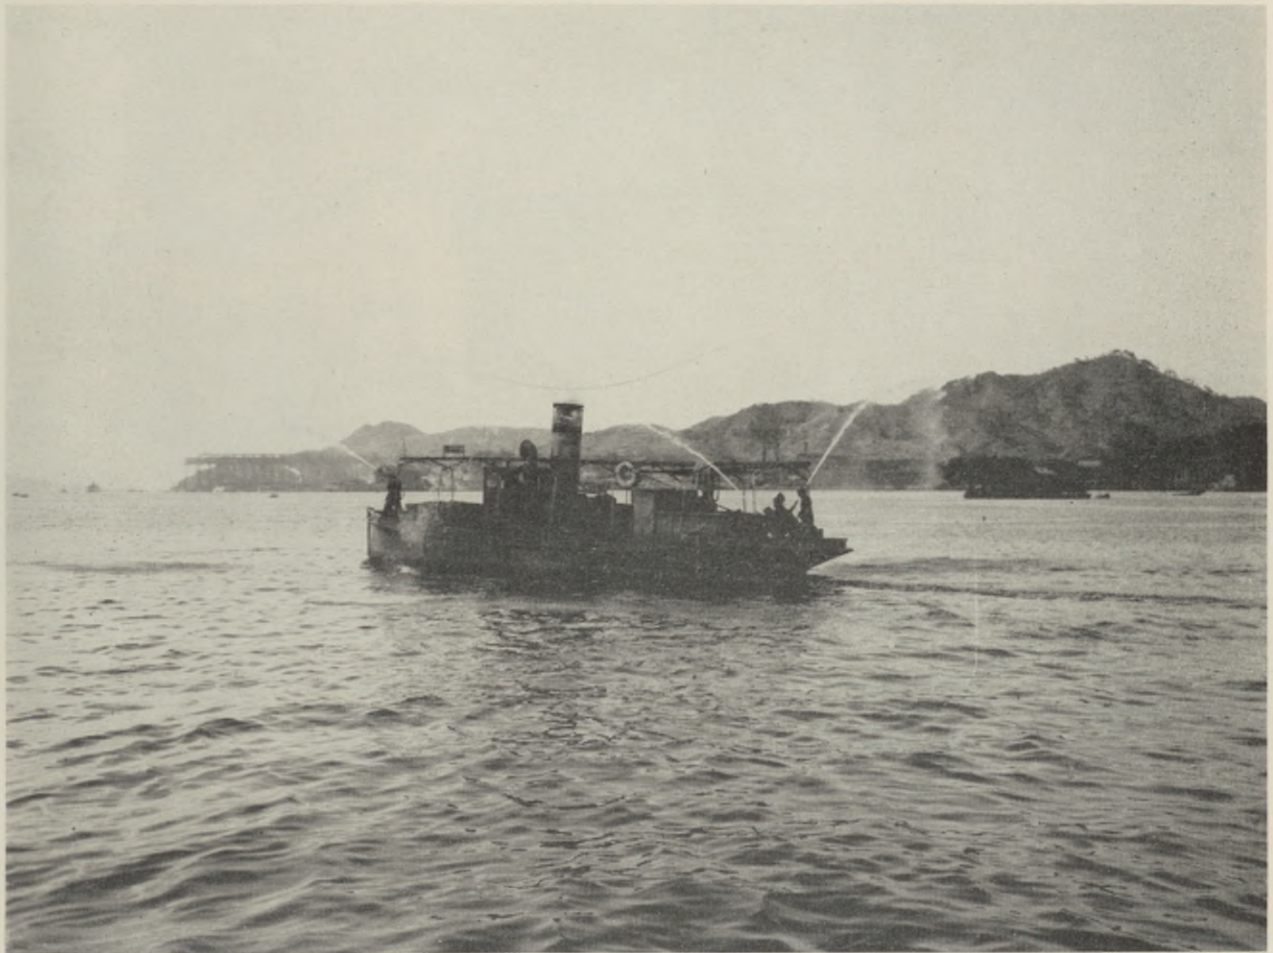
Photo 8. One of the two water police patrol boats, each equipped with a fire pump. Illustration shows two one-half-inch and one three-quarter-inch streams from a 350 g. p. m. pump driven by a Ford V-8 motor.

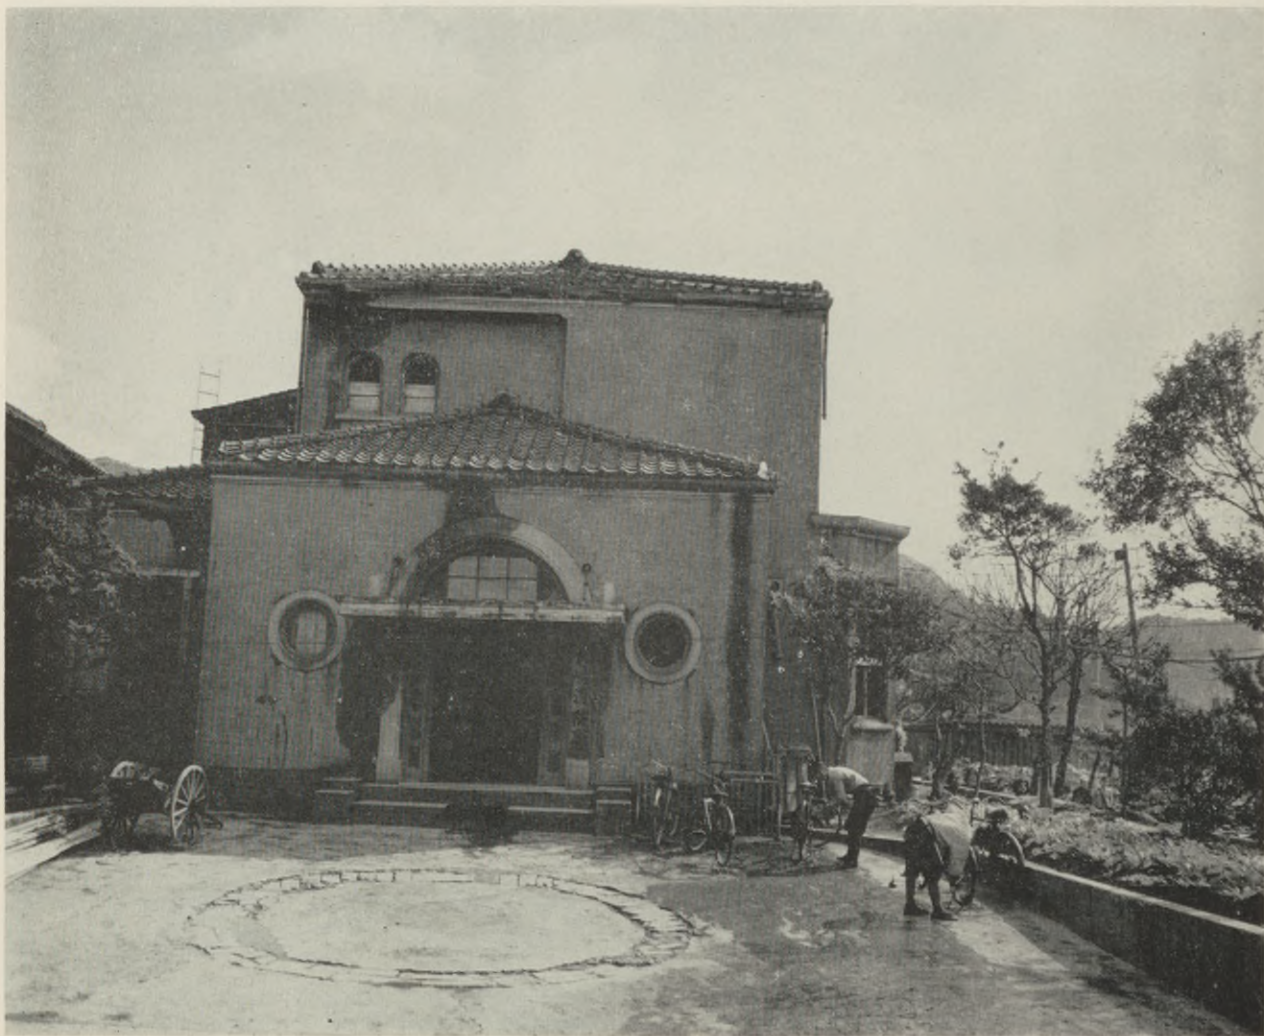
Photo 9. Nagasaki fire department headquarters building. No space provided to house fire equipment. Partially damaged by atomic bomb, 9 August 1945.

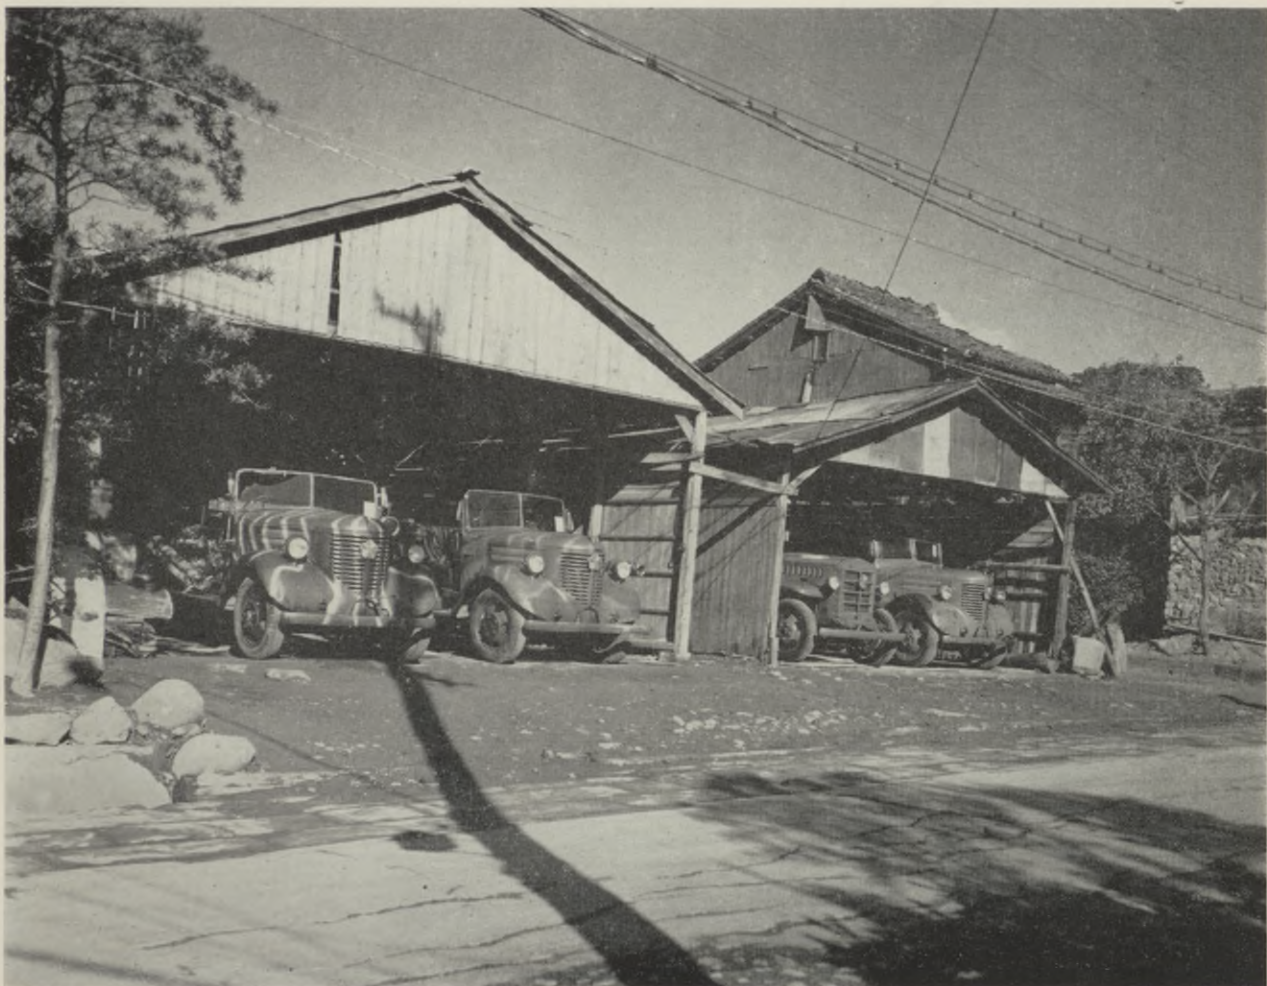
Photo 10. Permanent sheds for housing fire equipment, located directly across the street from fire headquarters building.

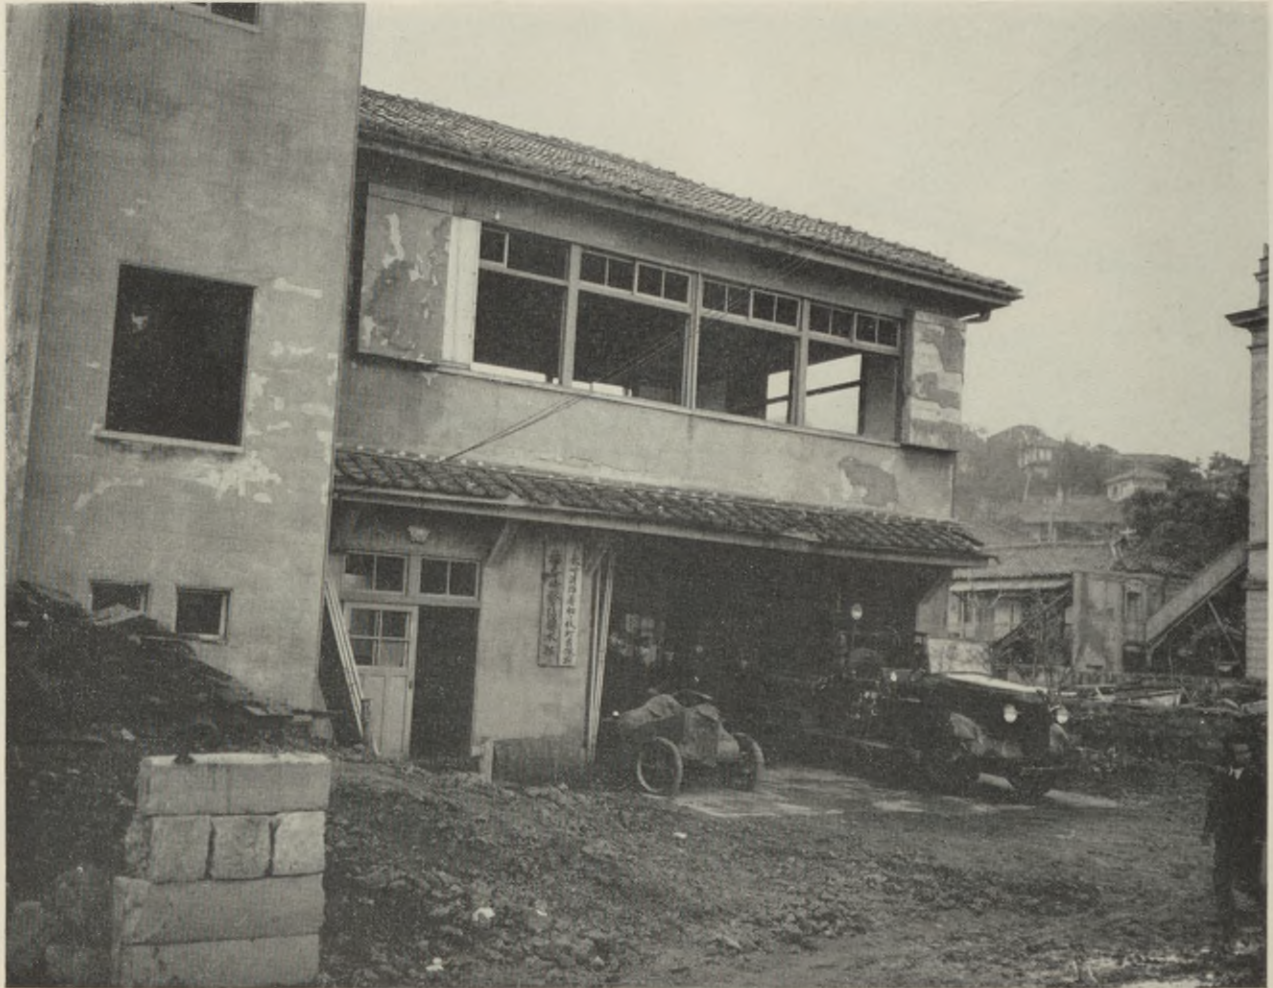
Photo 11. Matsugae Substation. Partially damaged by atomic bomb of 9 August 1945.

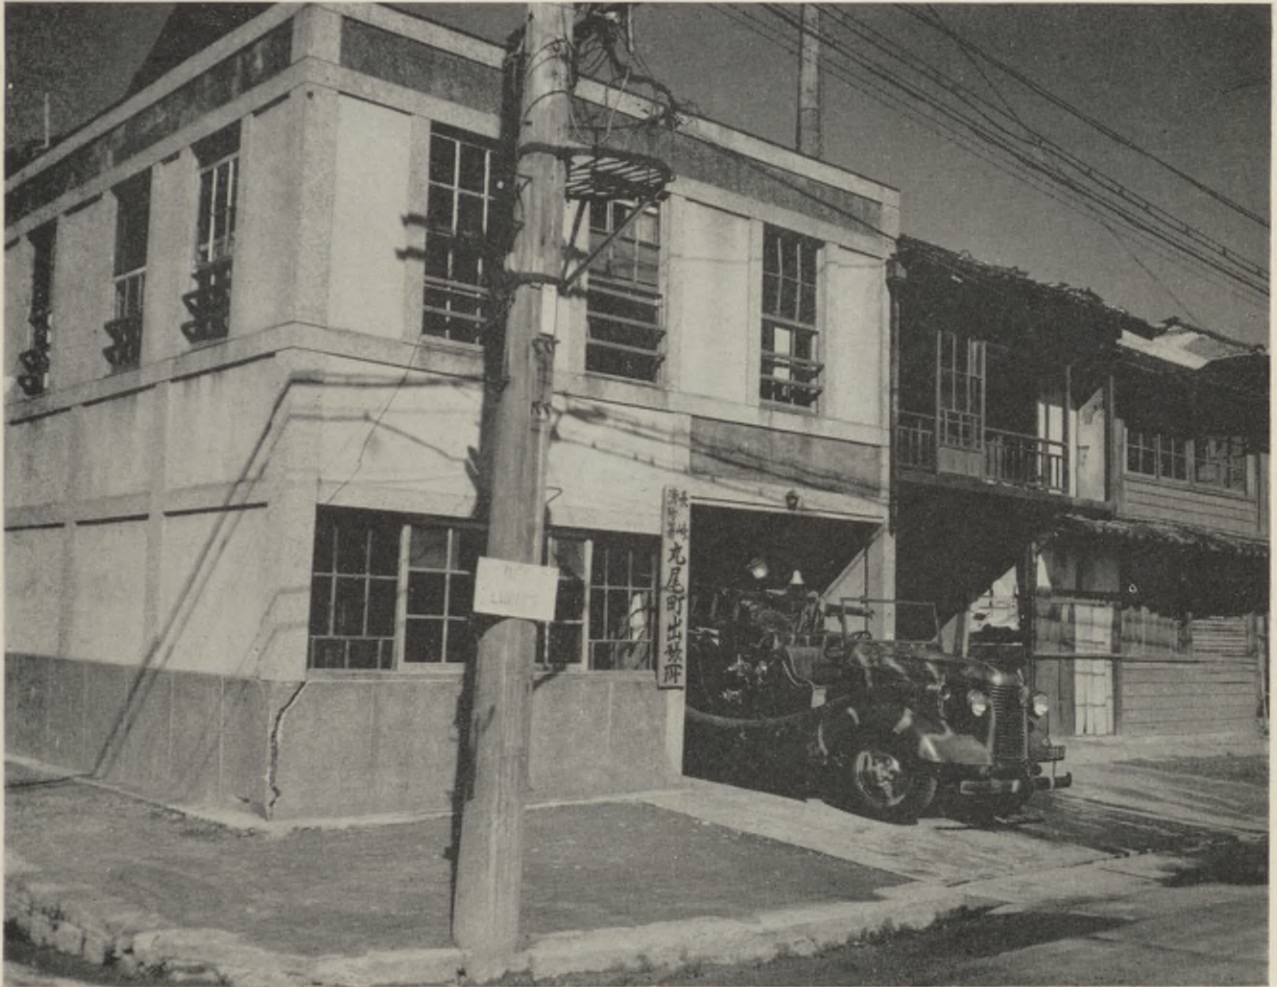
Photo 12. Maruo Substation. Partially damaged by atomic bomb, 9 August 1945.

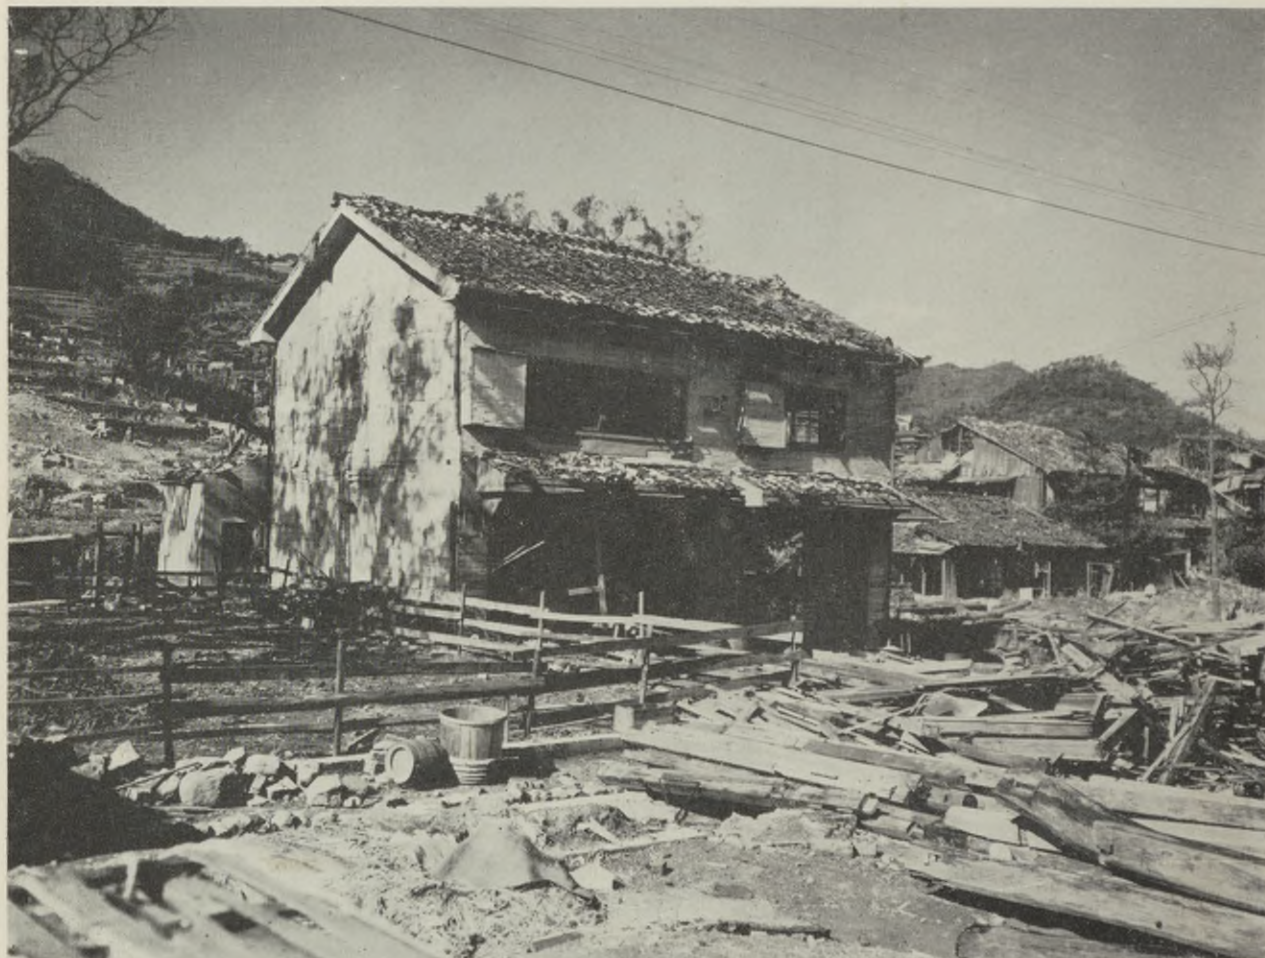
Photo 13. Inasa Substation, made untenable by a high-explosive bomb on 1 August 1945. No fire equipment or men were lost in this station.

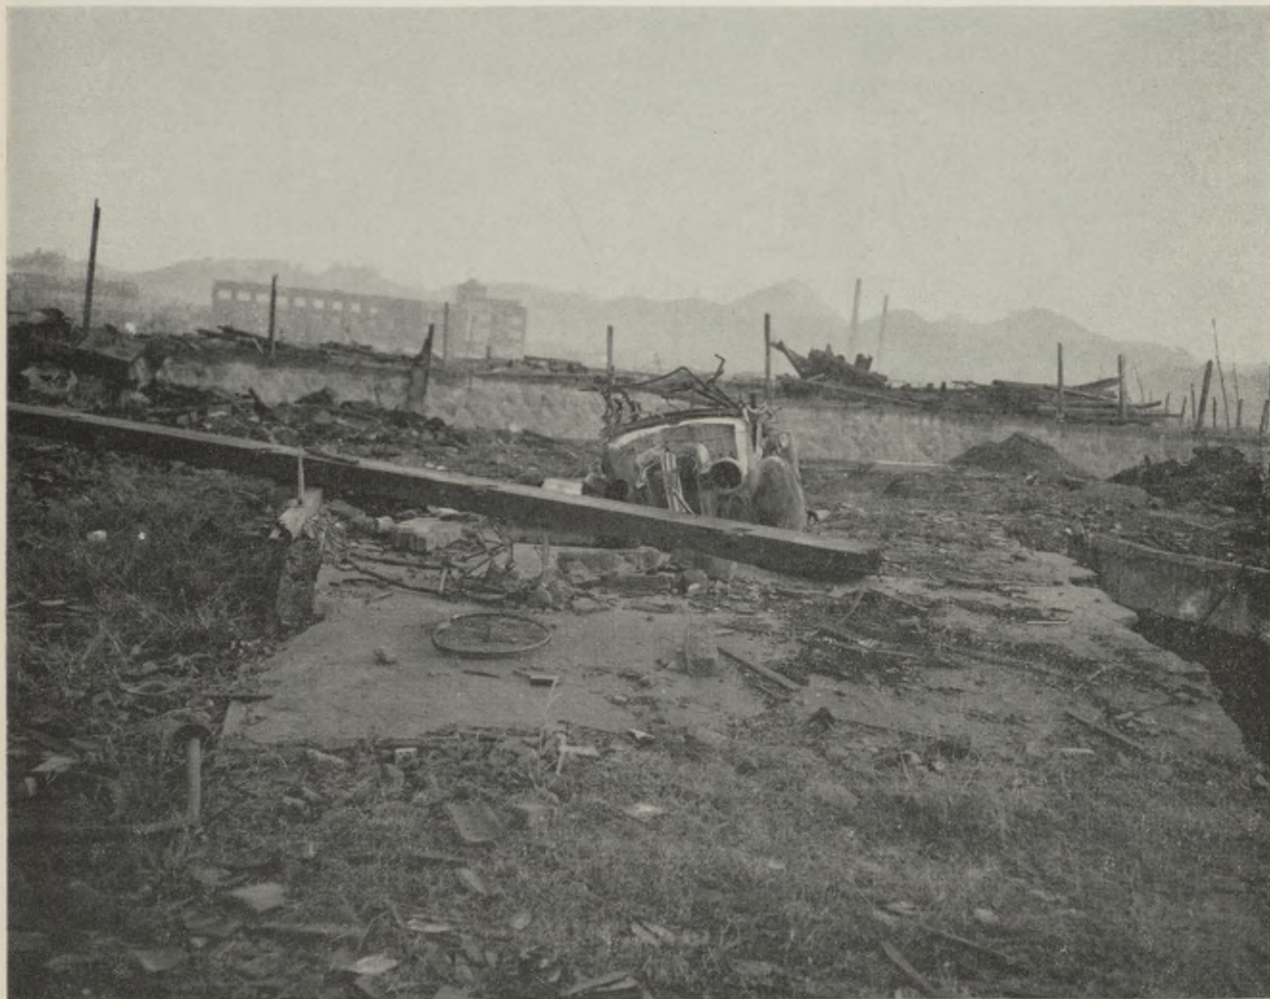
Photo 14. Ohashi Substation, completely damaged by atomic bomb. Nine firemen, the entire complement of this station, were killed.

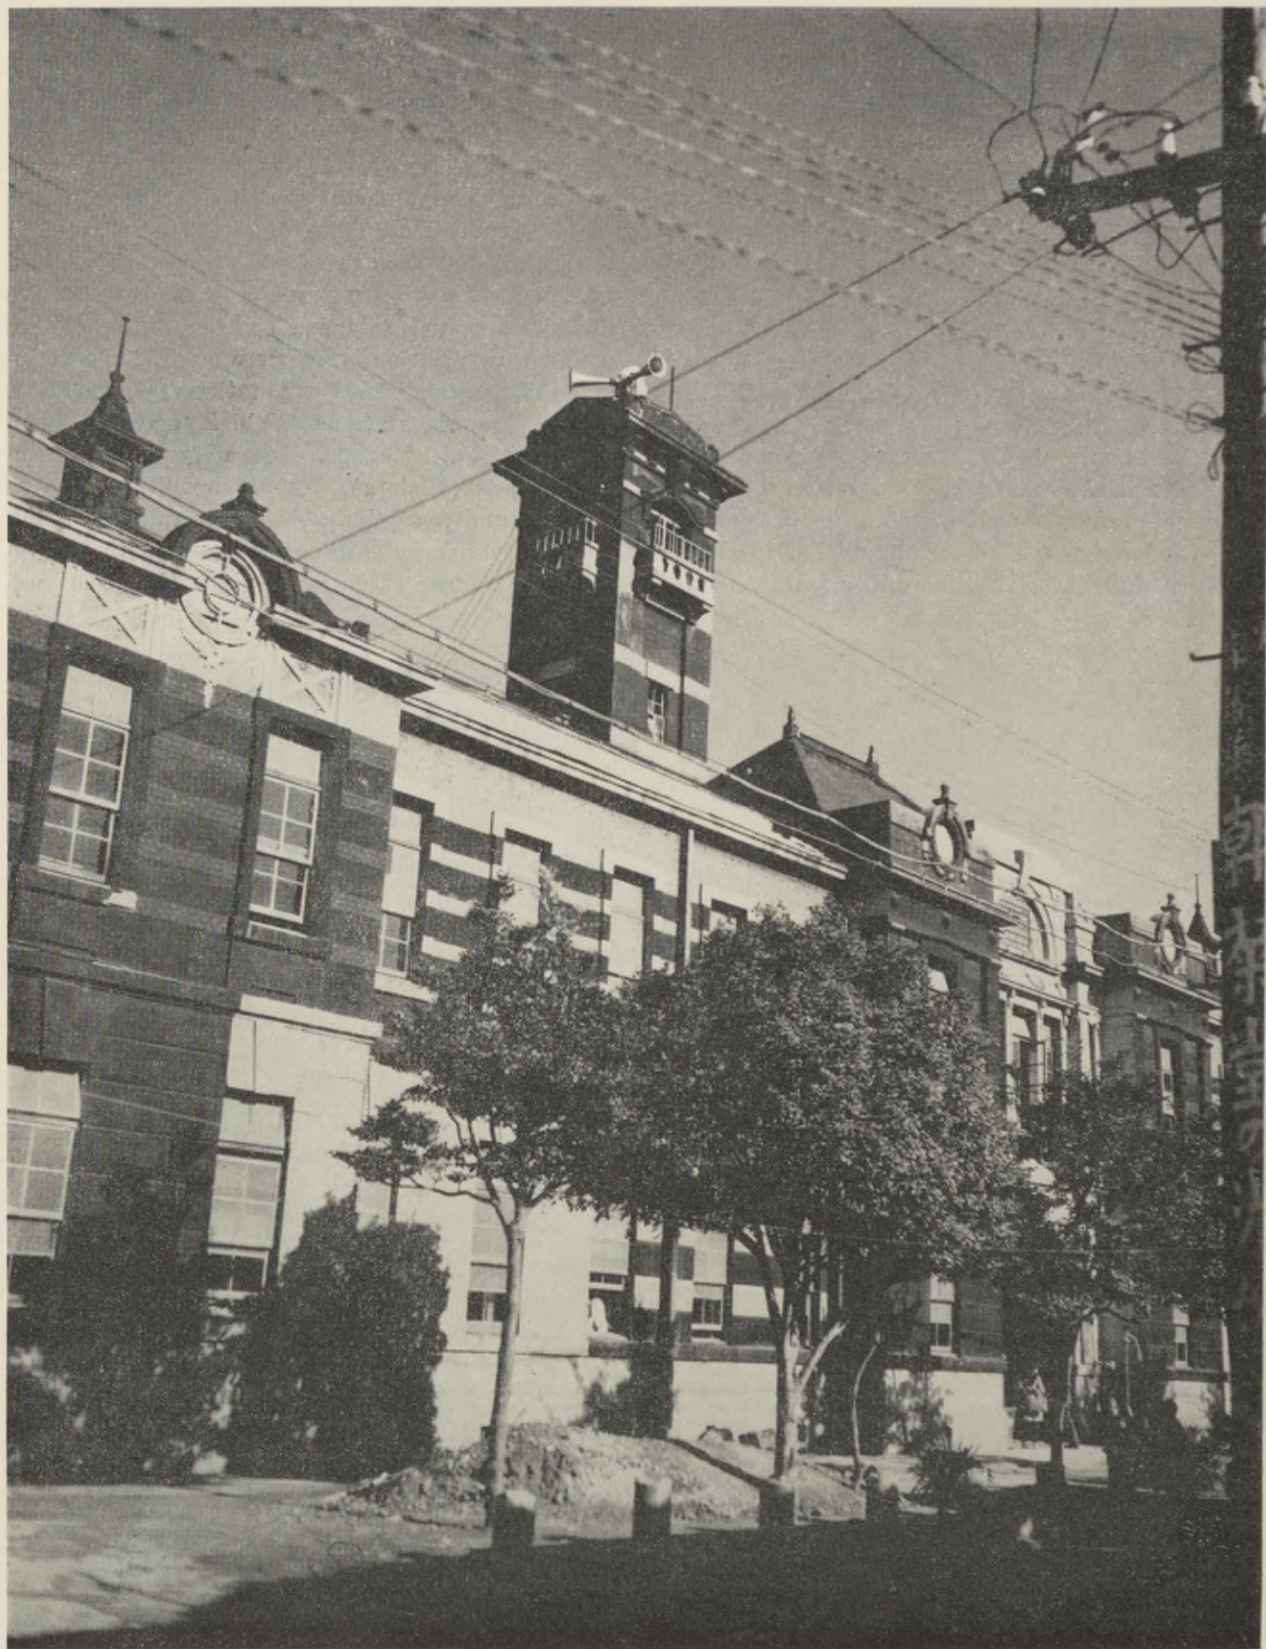
Photo 15. Fire watchtower, Nagasaki City Hall.

7. *Fire Alarm System.* The telephone and one watch tower were the only means of transmitting fire alarms. A person in reporting a fire by phone lifted the receiver and yelled, "Fire, fire!" to the operator. The phone operator, in turn, called the headquarters station where all fires were reported. Direct telephone lines from headquarters to the 4 substations were used by the fireman on phone watch in relaying fire alarms. The watch tower located on top of the city hall was manned by headquarters firemen who changed watch every hour (Photo 15). A direct telephone from the watch tower to headquarters station a short dis-

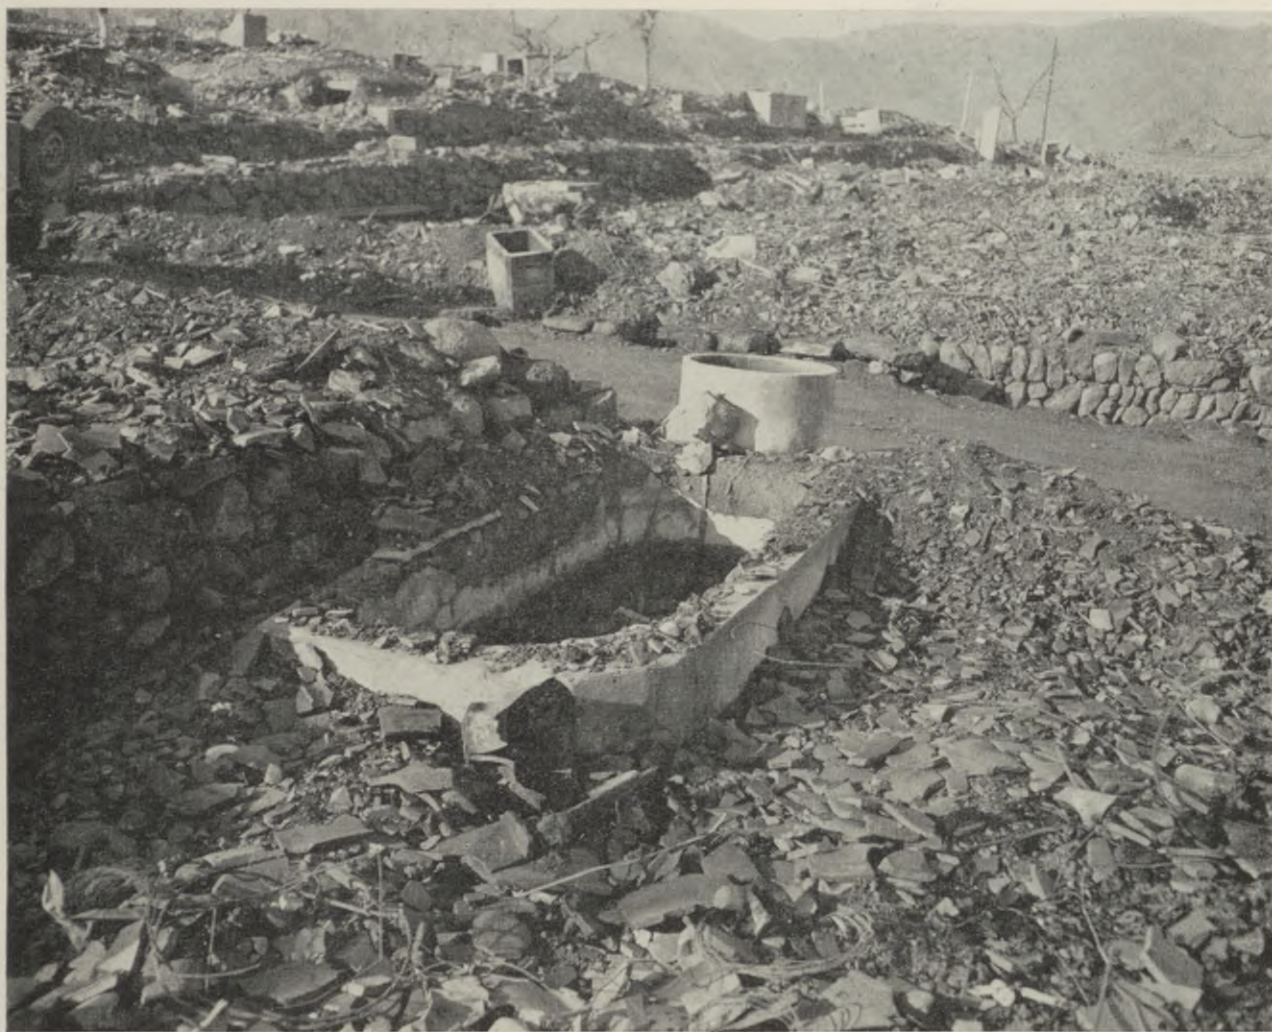
Photo 16. Small water tanks for fire fighting, made of dirt and plaster, built by some families. Concrete water receptacles, 40 to 70-gallon size, may be seen in background.

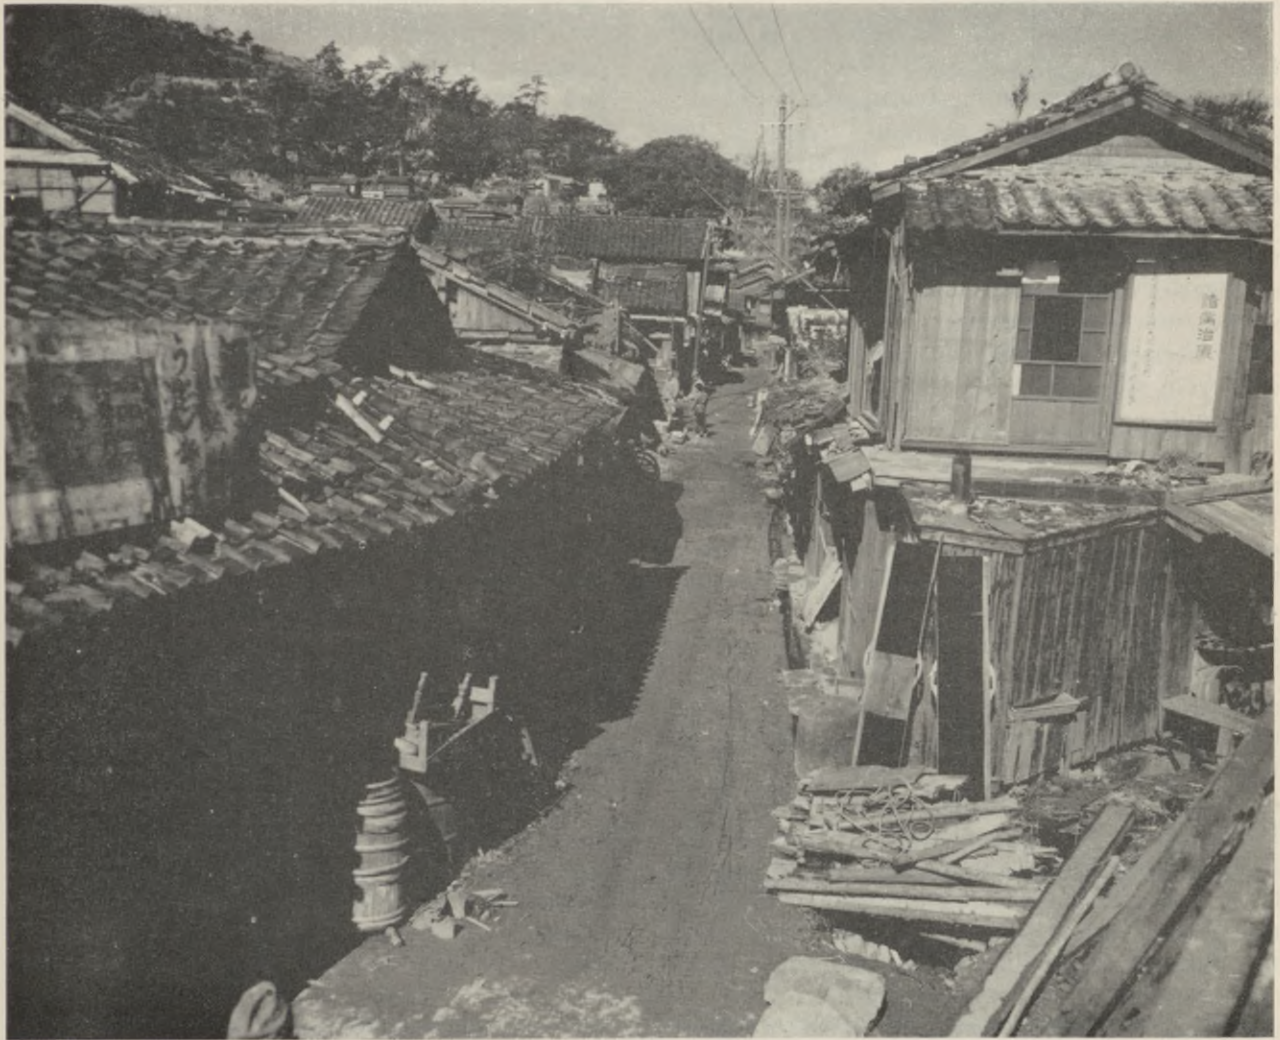
Photo 18. A congested section in Nagasaki (Inasa area). Streets are inaccessible to fire equipment and fire fighting is done by "bucket brigades."

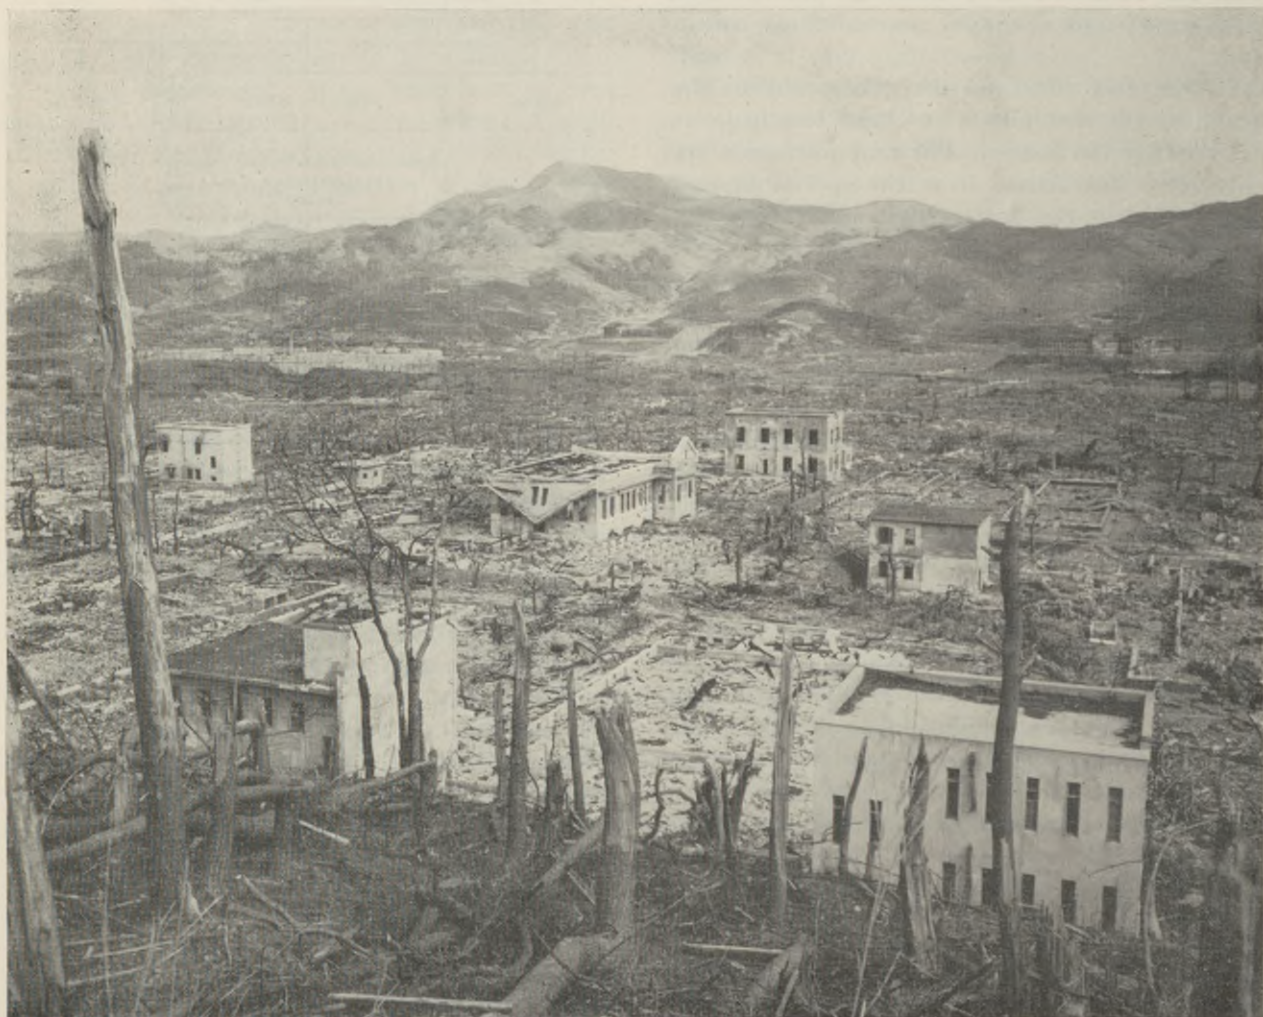
Photo 19. 1500 feet from ground zero. General view of remaining buildings, Medical College.

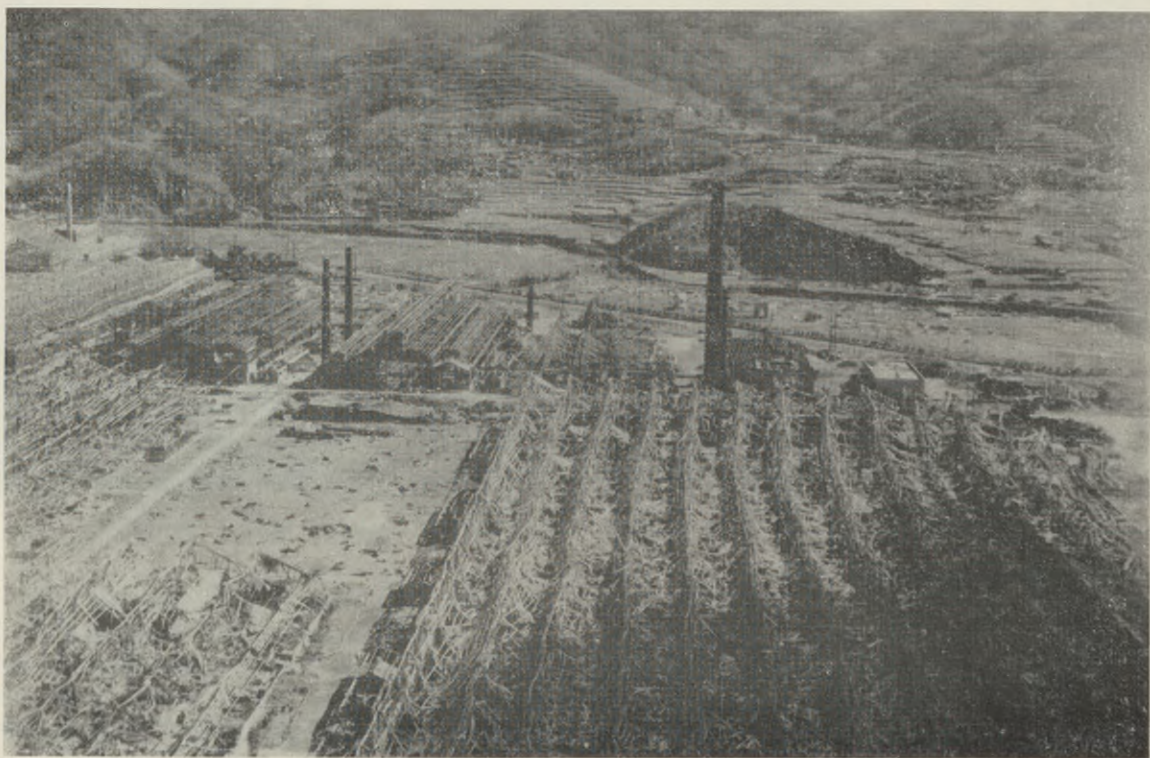
Photo 23. 4500 feet from GZ. Aerial view east.

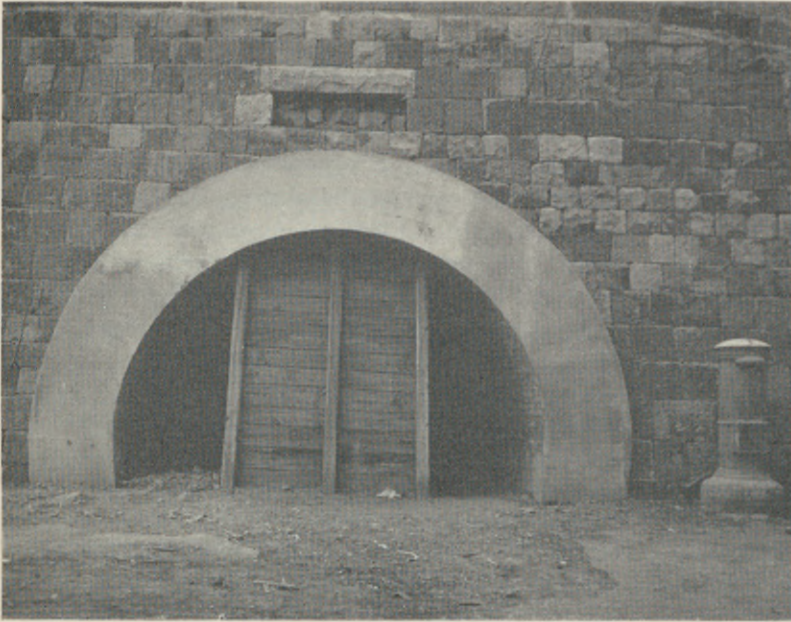
Photo 24. Tunnel-type, timber-reinforced shelter dug into the wall of the terraced parking lot of the Nagasaki Prefecture courthouse. Entrance also from the opposite end. Built by the city for the public.

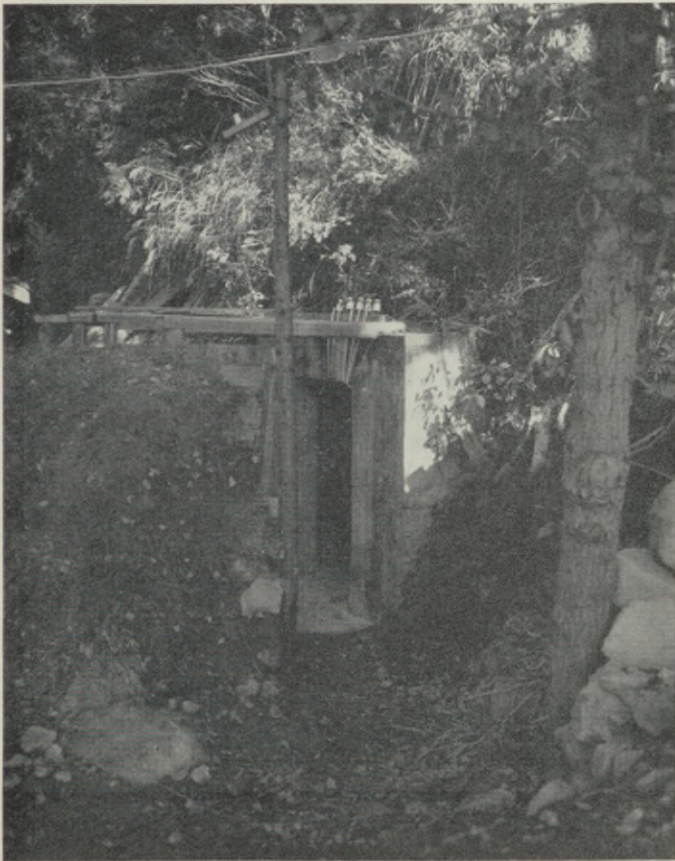
Photo 27. Another entrance to the above public shelter.
